Manhole Inspection Summary

Manhole # S23KK_030MH

Insp Date: **9/28/07 9:27 AM**

Location Address: **2461 WOODBROOK AVE**

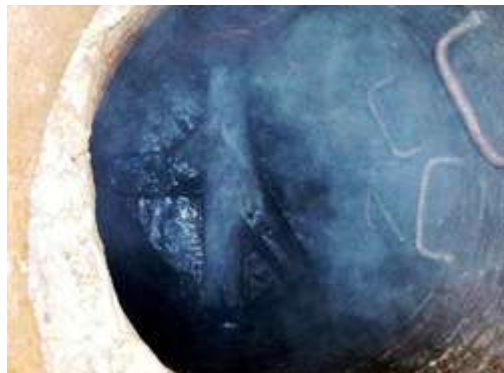
Top View

Corroded step. Bench debris.

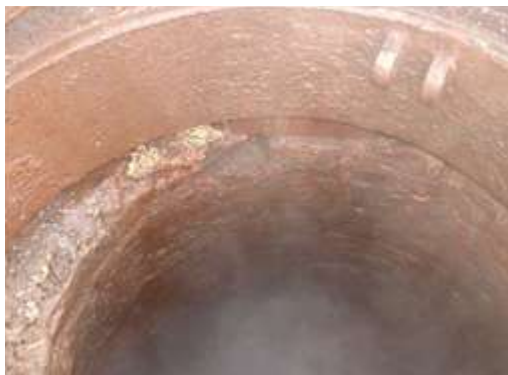
Defect

Frame leaks. Frame offset. Adjustment deterioration, loose brick and infiltration. Corbel and Barrel infiltration - other side.

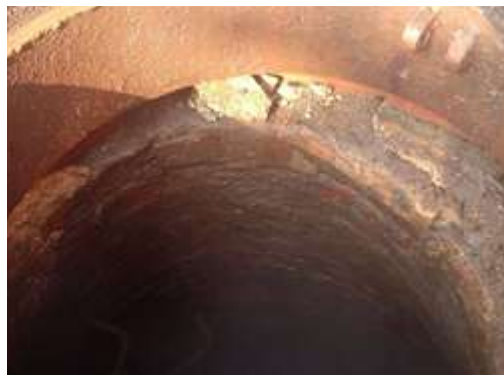
Defect

Frame leaks. Frame offset. Adjustment deterioration, loose brick and infiltration. Corbel and Barrel infiltration.

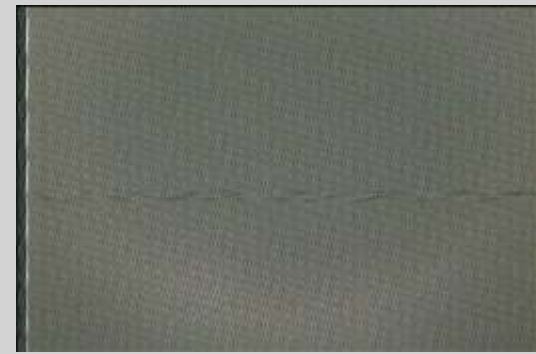
Pipe In @ 6 O'Clock

8 in. Circular Gravity Sewer

Pipe Material: **Clay** ☐ Pipe Lined

Invert Depth: **8.20** (ft.) Flow Characteristics: **Fast**

Infiltration: **None** Pipe Seal Cond: **Unknown**
